SERIAL NUMBER: WADC-TR-52-68

DATE: April 1952

PHASE V (ALL WEATHER) TESTING OF T-29A AIRCRAFT

All Weather Section
Flight Test Division
Project No. S207-20

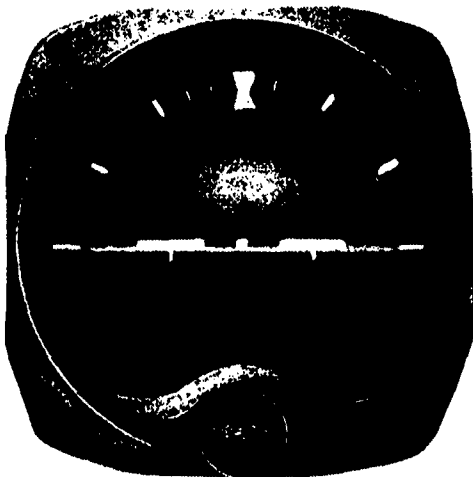
Attitude Gyro in run-up position.

As noted in the illustration to the left, the horizon bar is displaced in both pitch and roll. The pitch error can be adjusted by moving the reference plane to coincide with the bar, but there is no way of adjusting the roll error. Most pilots are capable of interpreting this error, although it does impose an additional workload at a critical time and thereby jeopardizes the instrument take-off. If a vertical gyro (J-8) incorporating a manual erection knob is installed, the pilot can center the horizon bar and eliminate the turn error.

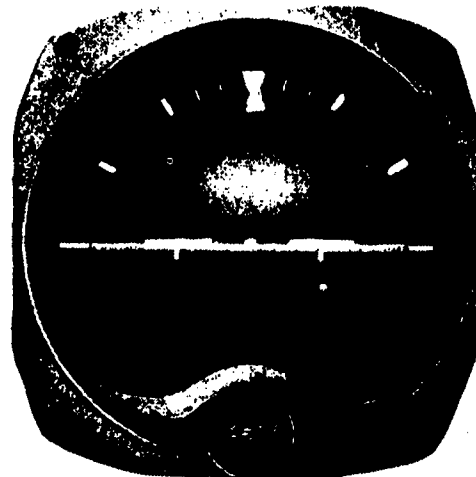
Attitude Gyro after run-up and in take-off position following two 90° turns which cancel out the precession.
